CAPE COD
COMMISSION

Pavement Management 2011 Status Report

October 2011

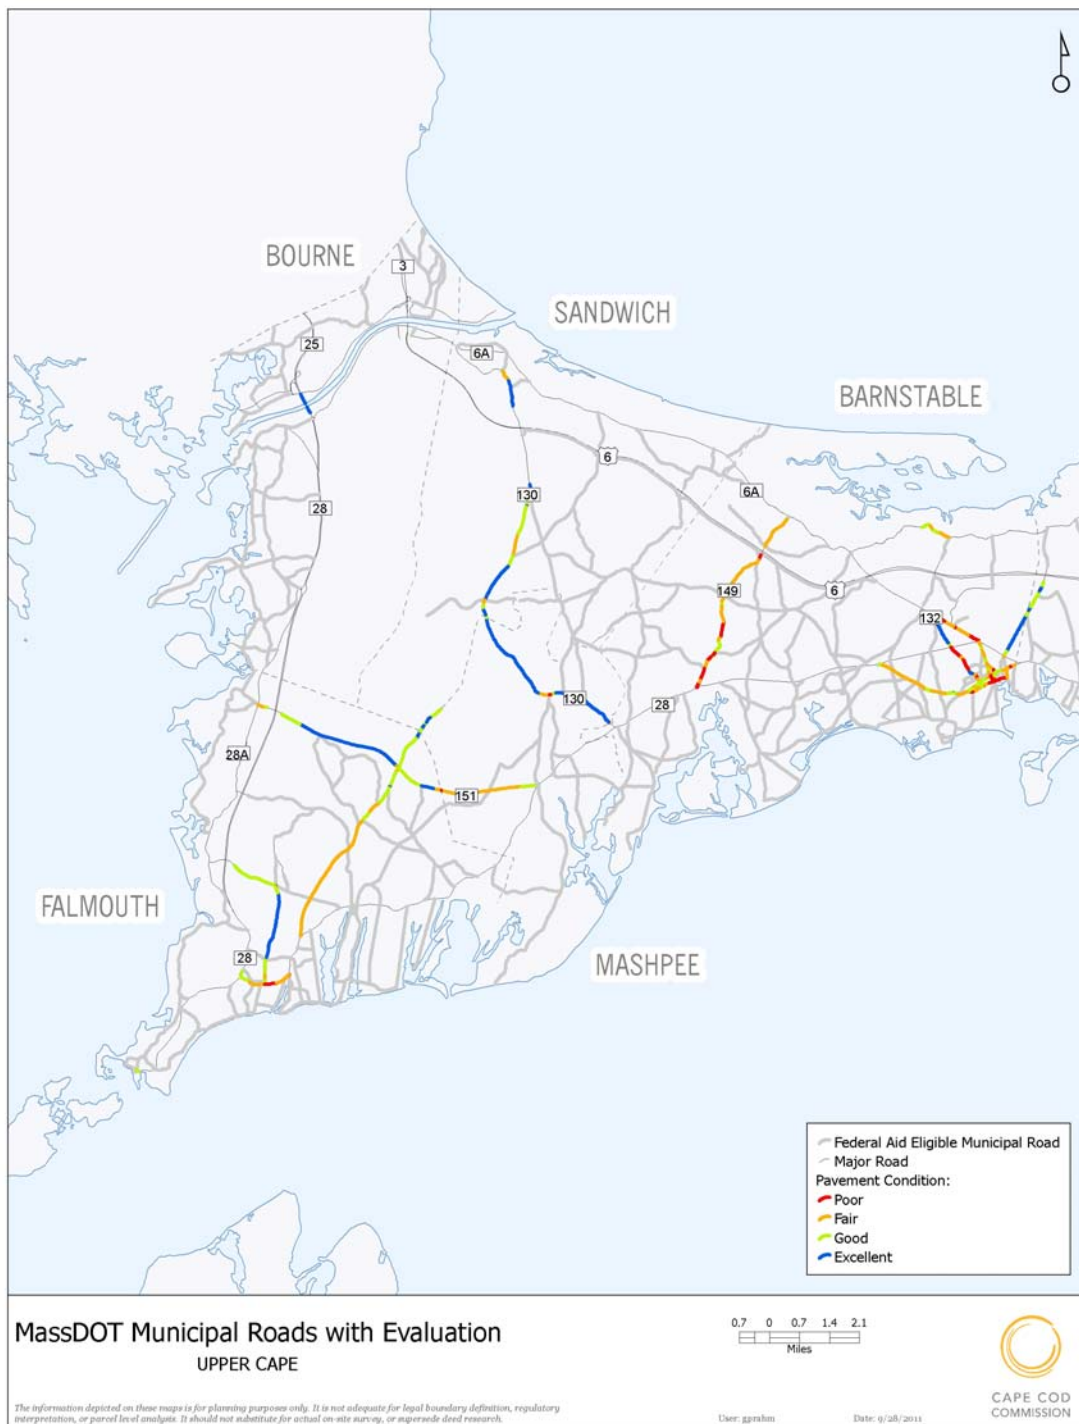
The maps in the following figures shows the four categories of pavement condition(see Table 5) on the MassDOT-evaluated roadways available in a series of three maps (Upper Cape, Mid Cape, and Lower Cape). The MassDOT evaluations are shown as thick solid colored lines ranging from Blue (Excellent) to Red (Poor).

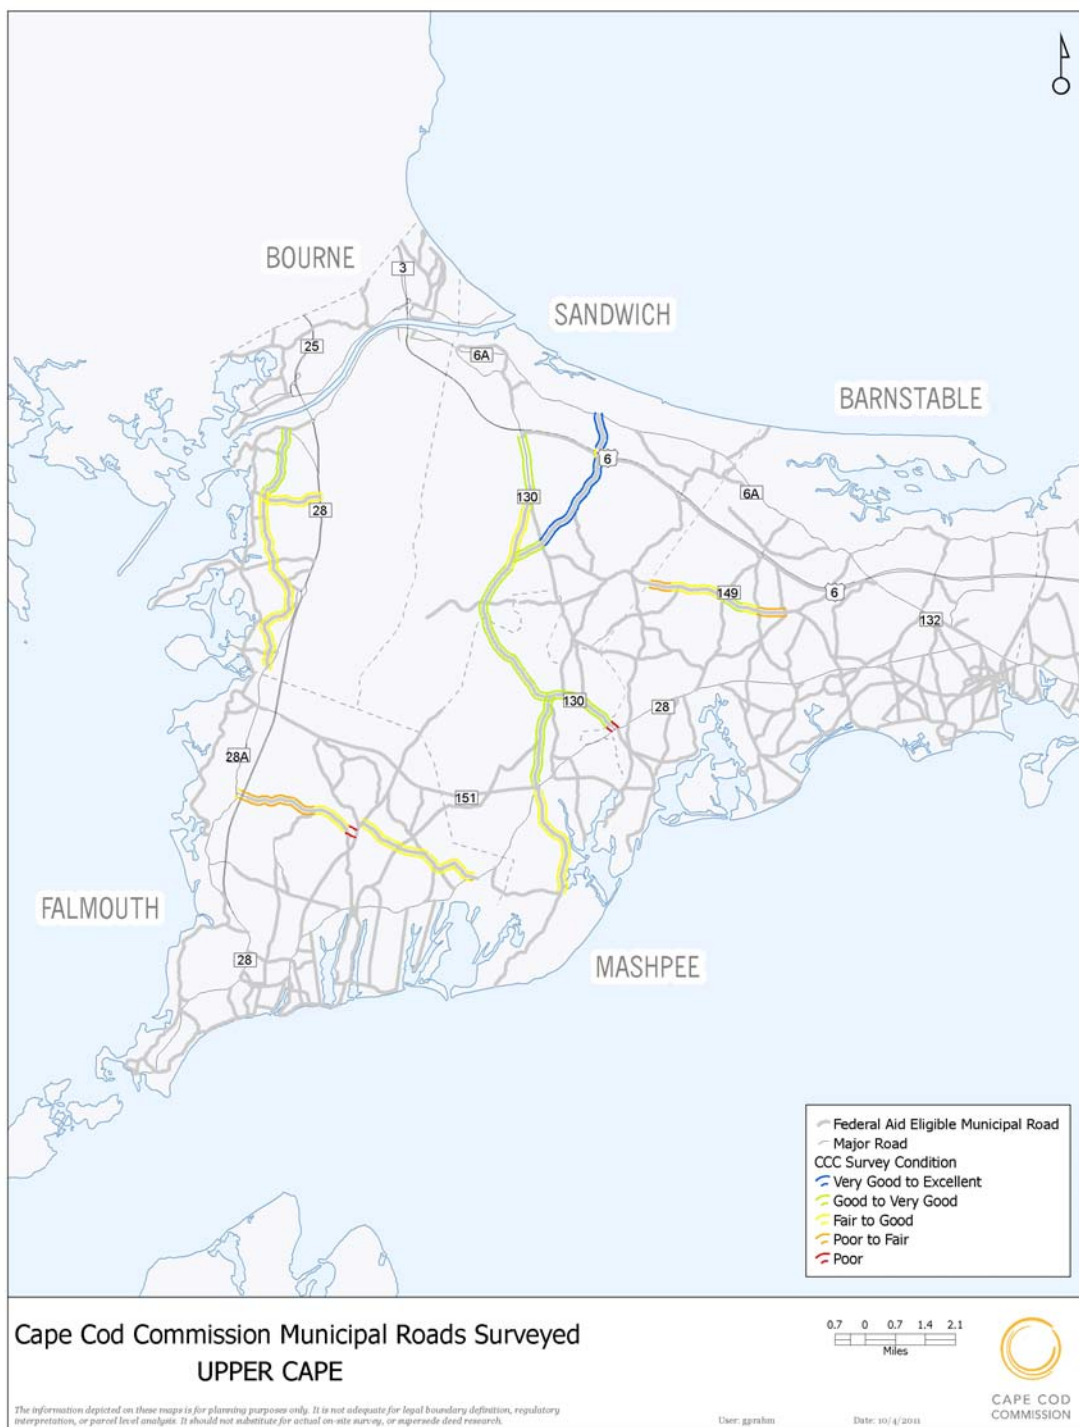
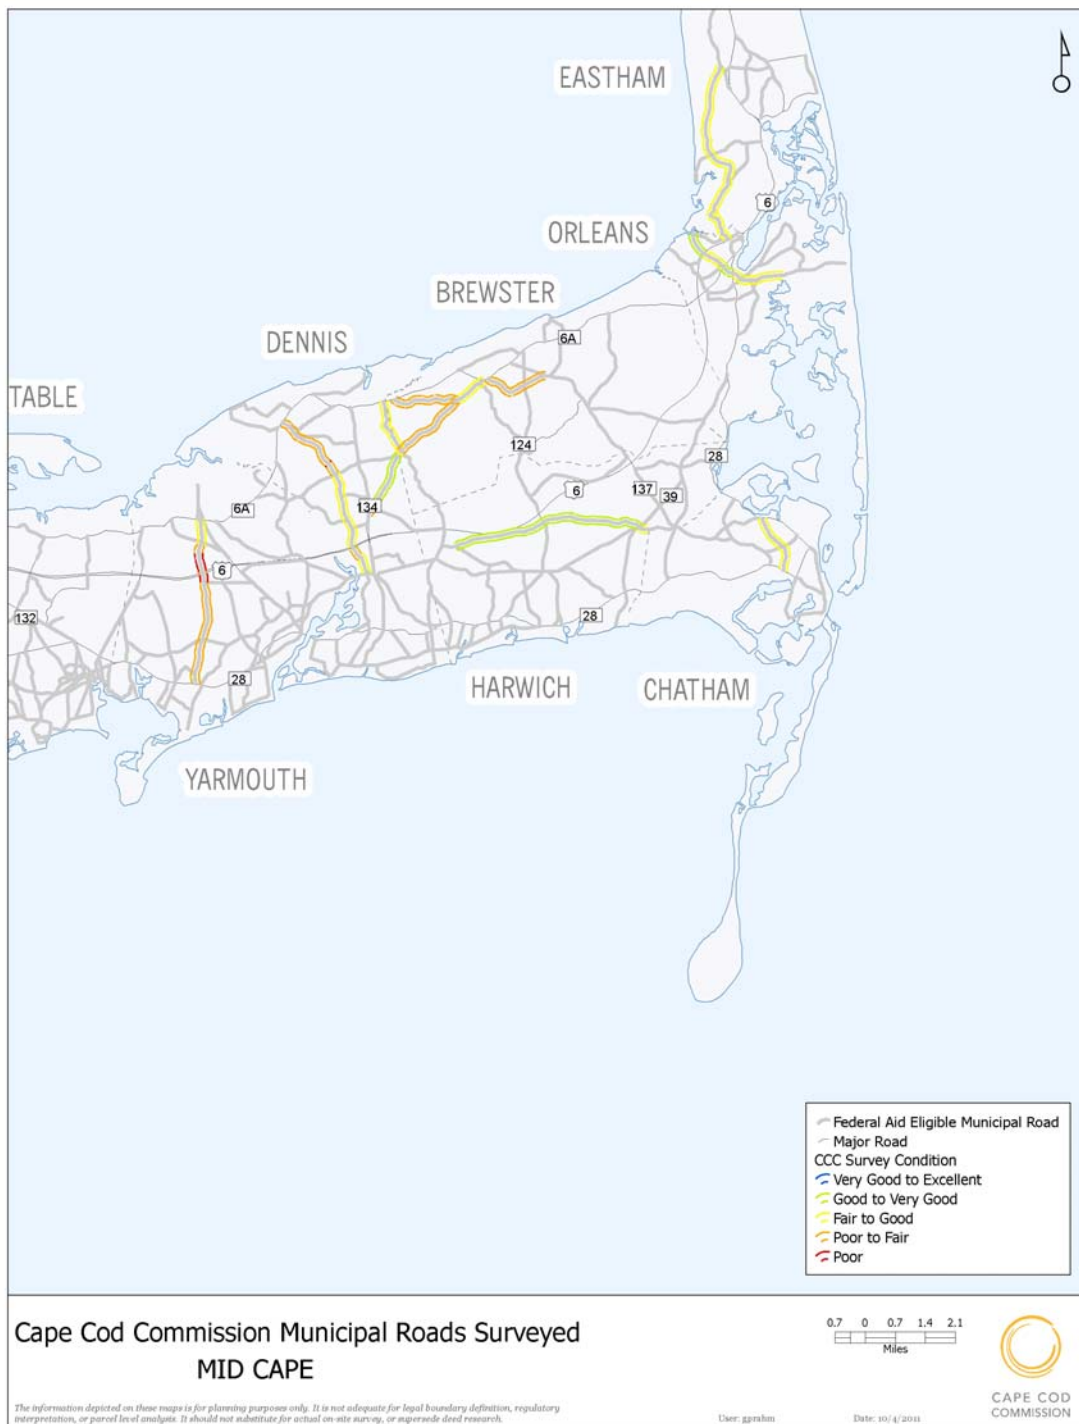
The following figures provide a graphic of the CCC survey data in a series of three maps (Upper Cape, Mid Cape, and Lower Cape). The CCC evaluations are shown as colored parallel lines ranging from Blue (Very Good to Excellent) to Red (Poor).

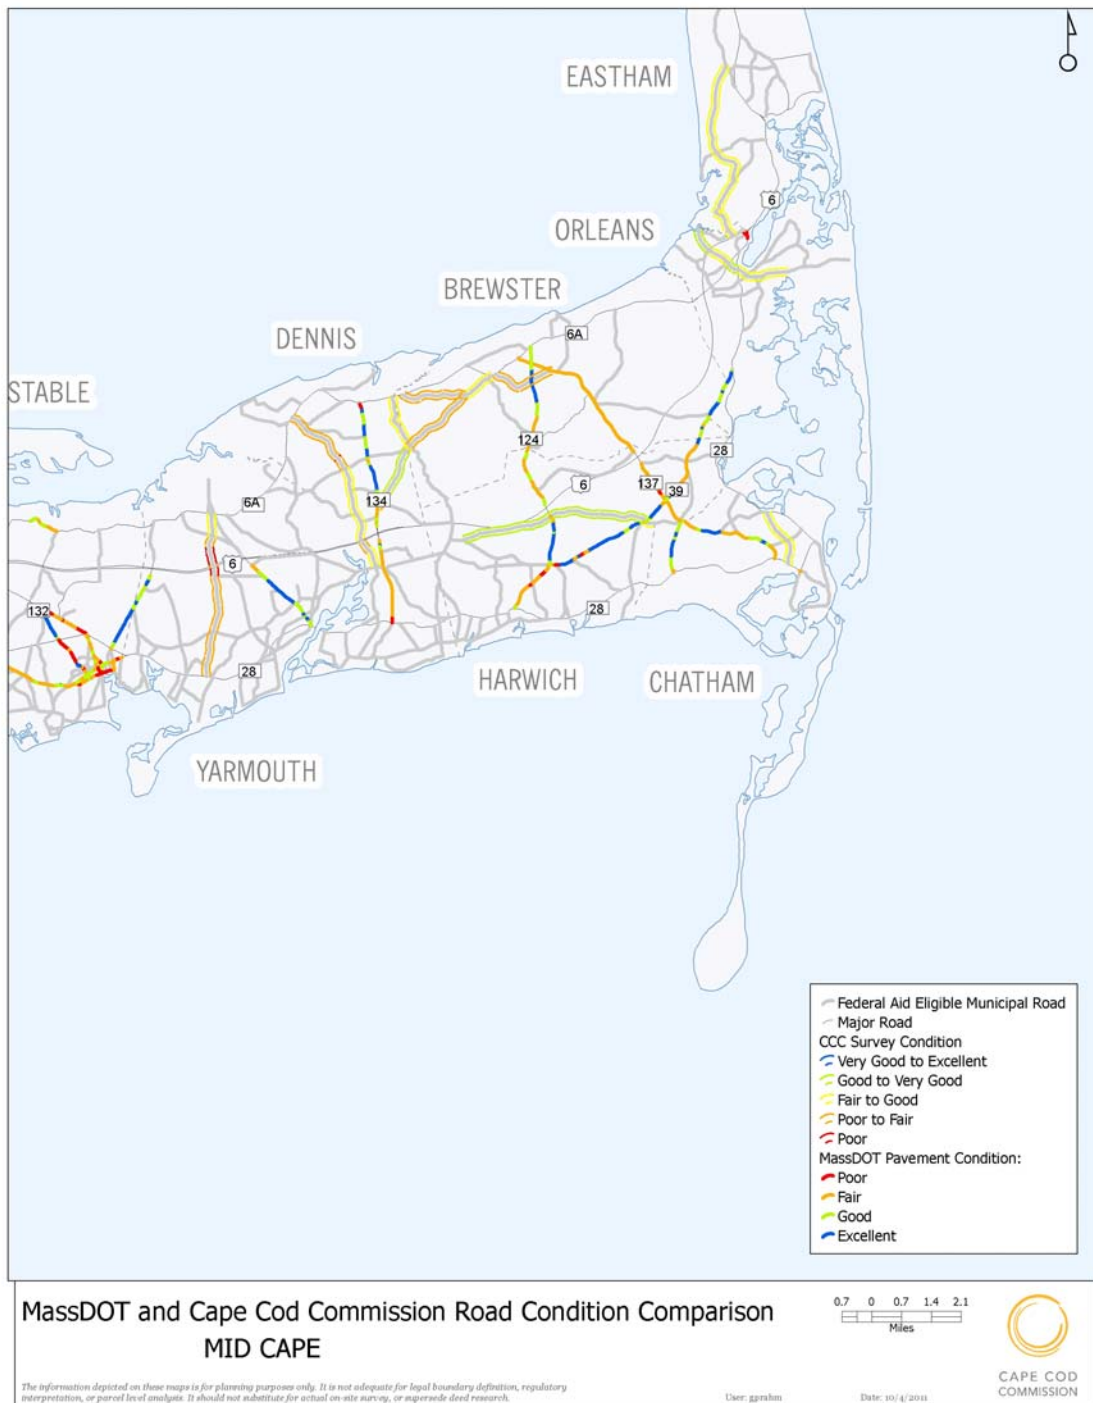
When combined with MassDOT's "Municipal Roads with Evaluation" information, the following figures represent over 145 miles of the County's Municipal Roads. In some cases CCC evaluations were made on sections of roads also evaluated by MassDOT. The figures are presented geographically (Upper Cape, Mid-Cape, and Lower Cape) and show the combined evaluations by colored lines. For MassDOT evaluations, the colors of the thick solid lines range from Blue (Excellent) to Red (Poor). For the CCC evaluations, the colors of the parallel lines range from Blue (Very Good to Excellent) to Red (Poor).
